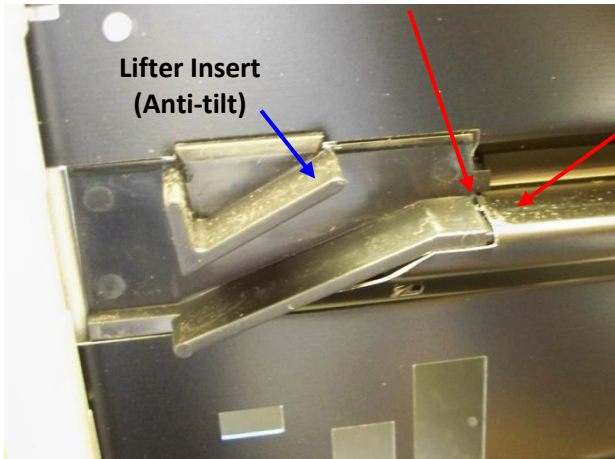
Slight gap between
Lifter Insert & Drawer
Body forming.

To cure the snagging re-fit the Lifter
Insert by tapping back against the metal
form, and tap the end of the metal
formed edge down flush with the end of
the Lifter Insert.

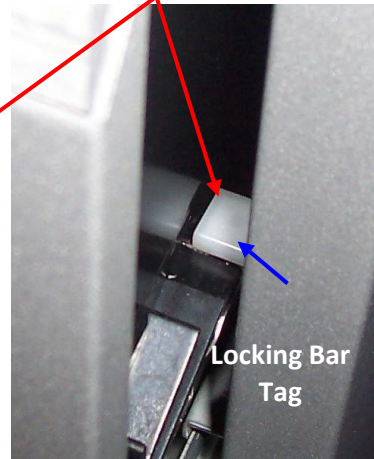
Mainly as the drawer is closed the
locking bar tag catch snag on the end of the
metal formed edge.

Tap
downwards.
